Atomic Oxygen Durability of Solar Concentrator Materials for Space Station Freedom

Kim K. de Groh
Lewis Research Center
Cleveland, Ohio

Prepared for the
Fifth Annual Air Force Workshop on Surface Reactions
in the Space Environment
sponsored by the Northwestern University
Evanston, Illinois, September 24-25, 1990

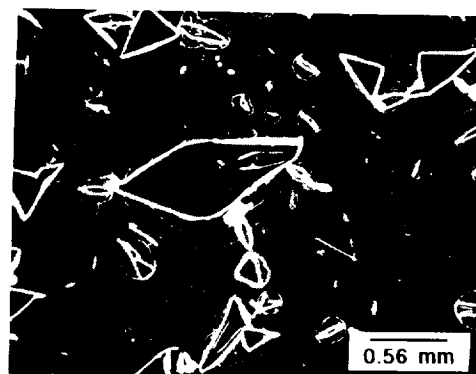
Figure 5. Atomic oxygen undercutting and tearing at a circular defect. Concentric white rings indicate the extent of undercutting at various fluence levels: a. pristine, b. $F= 1.57 \times 10^{21}$ atoms/cm², c. $F= 3.1 \times 10^{21}$ atoms/cm².

Tearing of the reflective and protective films allows exposure of more substrate material which further erodes, thus continuing the undercutting-tearing propagation process. A circular defect which was undercut and torn can be seen in figure 5. The approximate extent of undercutting at the various ashing intervals is shown by the white rings around the defect areas. If tearing did not occur, it might be expected that the undercut region would reach a diameter limit^{6,8}.

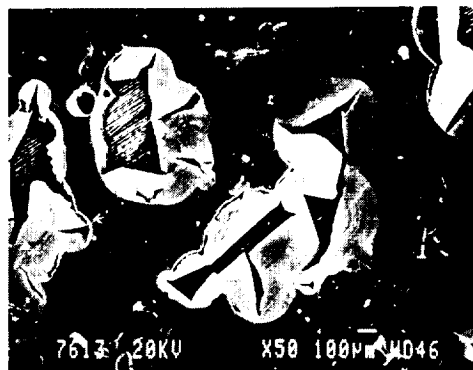
Figure 8. Scanning electron micrographs of undercut regions: a. exposure of graphite fibers due to tearing of the reflective and protective films, b. flaking off of unsupported films at extensively undercut regions.

Using scanning electron microscopy, the atomic oxygen erosion processes at defect sites were examined in detail. If the original atomic oxygen transparent defect is very small ($< 5\mu\text{m}$) it appears that the undercut region reaches a limiting size and tearing of reflective and protective films does not generally occur. Extensively undercut larger defects caused tearing of the unsupported film. Silver oxide was found to be present at many of the torn cracks and defect openings. If the torn region becomes large enough, the protective and reflective layers which are now unsupported, start to curl. This leads to exposure of large regions of the underlying substrate and lets the atomic oxygen react with fresh, previously protected substrate material, as shown in figure 8a. As the undercutting-tearing propagation cycle continues more undercut regions run into each other. Eventually the protective and reflective films not only curl but flake off, as can be seen in figure 8b. Extensive undercutting damage of this kind leads to specular reflectance loss (resulting in decreased system efficiency) and solar absorptance increases (resulting in increased heating and warpage of the solar concentrator) as well as structural damage to the concentrator.

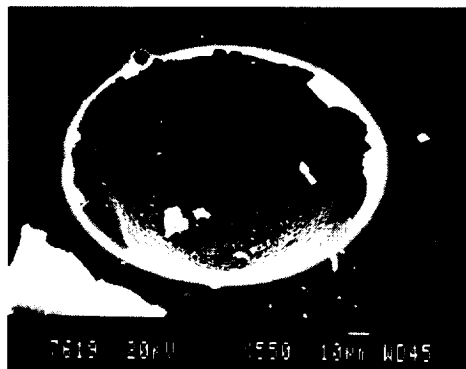
Figure 9. Atomic oxygen erosion processes: a. epoxy erodes with a rounded bottom profile, b. more atomic oxygen atoms scatter at the graphite fiber-epoxy interface (due to the lower erosion yield of graphite) resulting in wider undercut regions, c. graphite fiber erosion below an original defect window in 9b.

By examining areas where the reflective and protective films have flaked off, the atomic oxygen plasma erosion process was further evaluated. As the atomic oxygen attacks the epoxy, a rounded bottom profile forms (see figure 9a). A very slight angled chamfer at the protective coating interface can be noticed which is attributed to a double dimple effect for wide defect width-to-coating thickness ratios³. As erosion continues in large defects, it eventually reaches the first graphite layer. Because the erosion yield of graphite is less than that for epoxy, more of the impact atoms are scattered and the undercutting region is spread out wider, this can be seen in figure 9b. As atomic oxygen attack continues, the graphite fibers are slowly eroded away. Erosion of the graphite fibers can be seen in the center of the undercut regions in figure 9b; these regions are located below the original defect window. A close up of this fiber erosion as shown in figure 9c.
